City of Riviera Beach

Assessment, Analysis and

Corrective Action Related to

Consent Order for Utility District

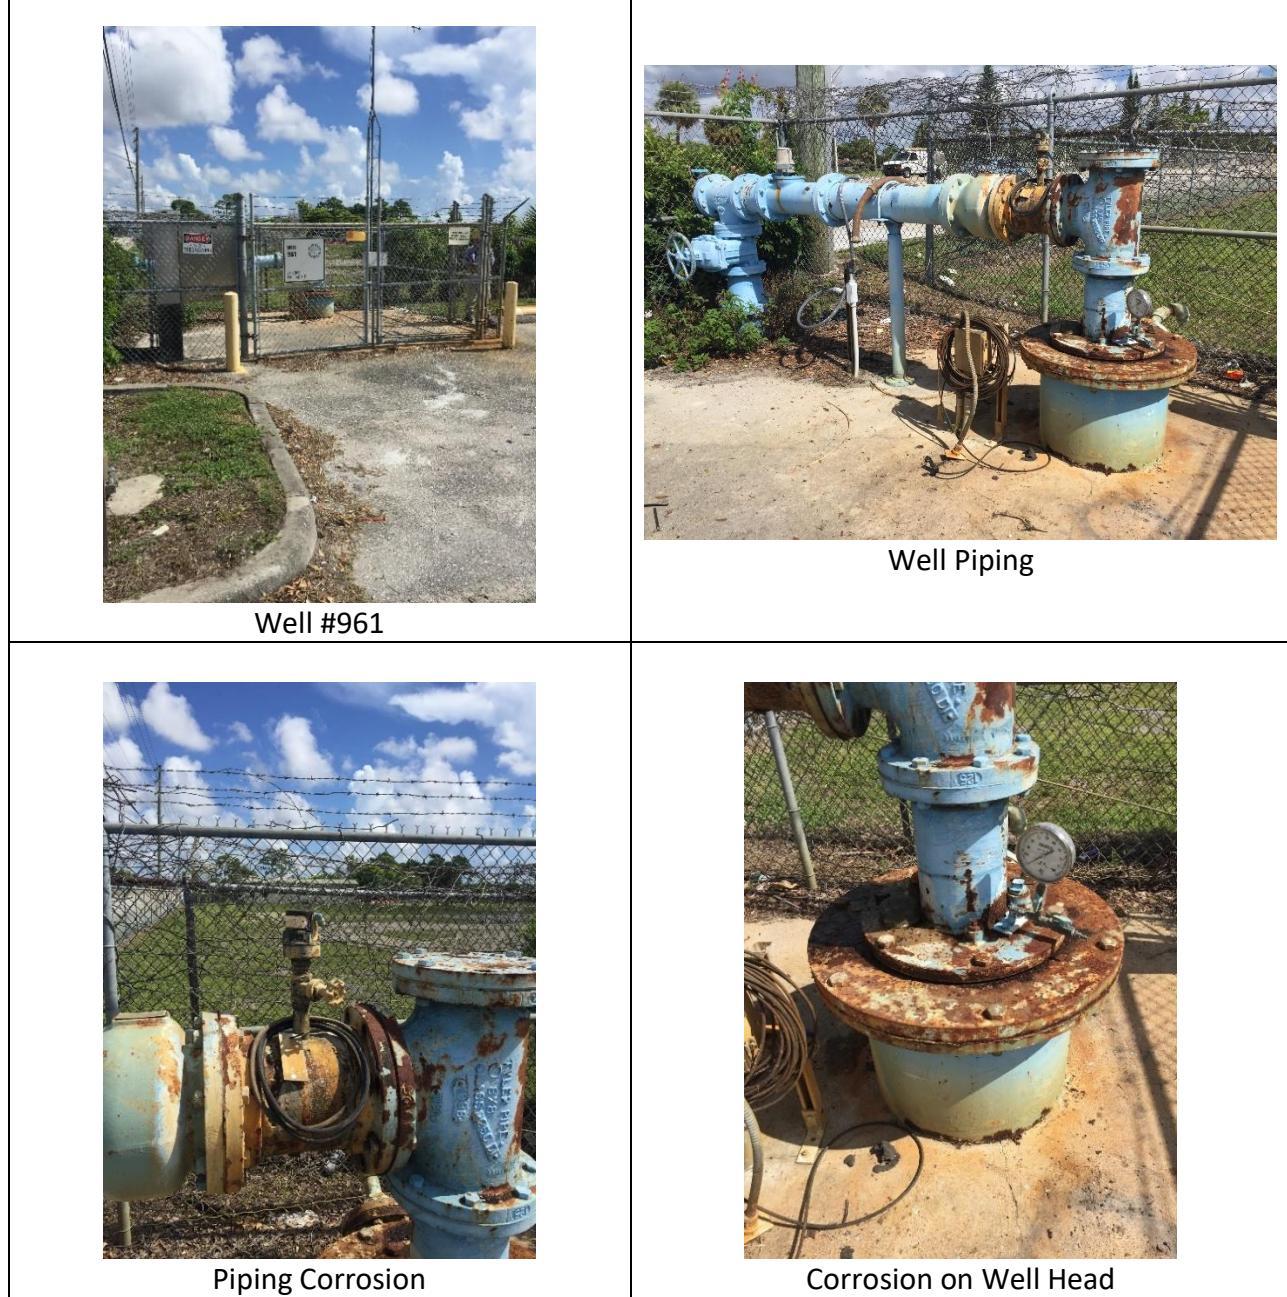
Well #961; Out of Service; Location – Military Trl & Canterbury Dr

Piping Corrosion

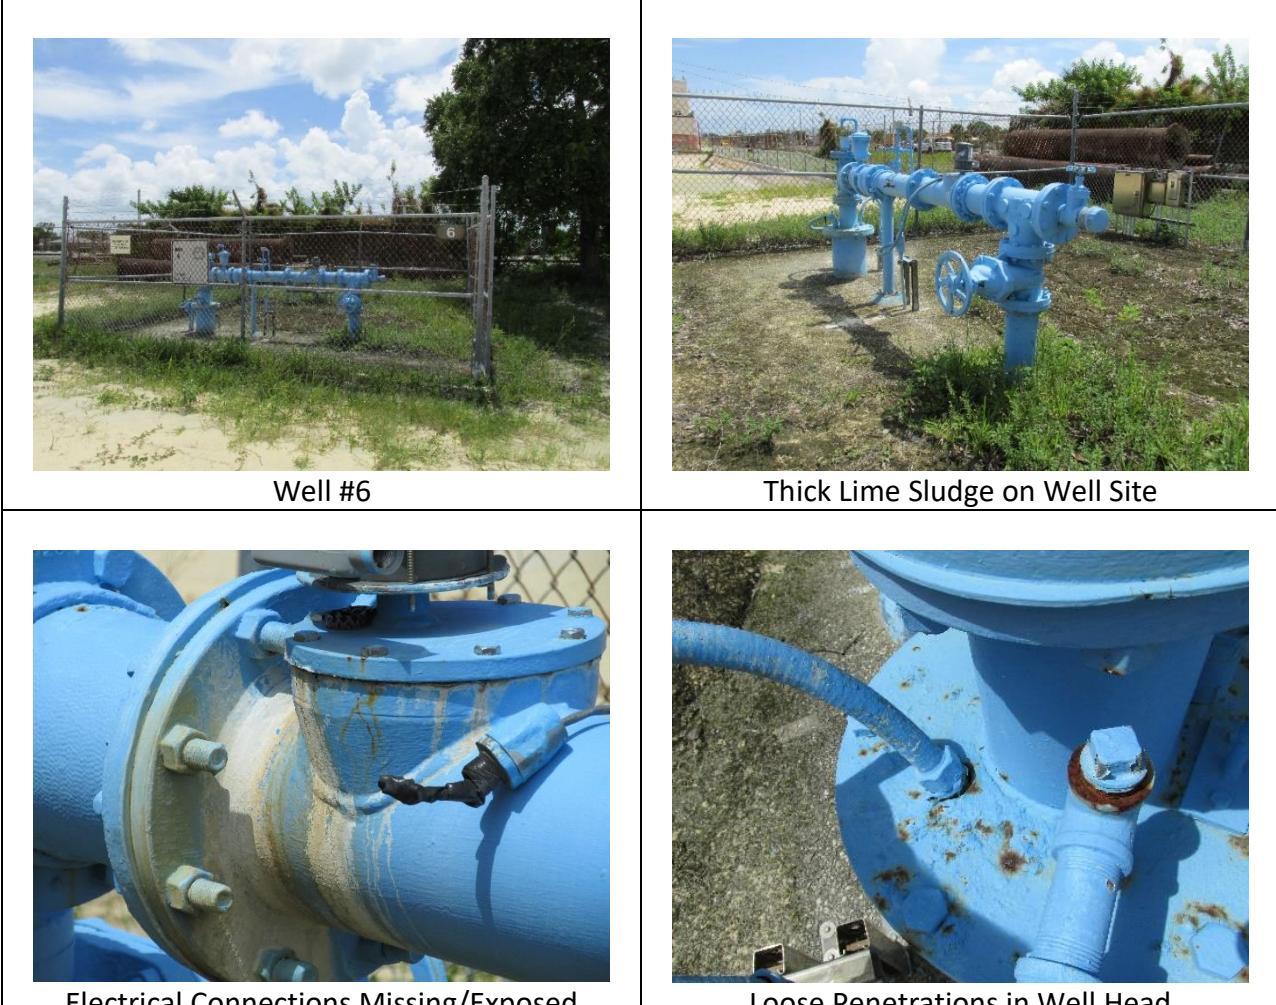
Well #6; In Service; Location – WTP South of maintenance building

Electrical Connections Missing/Exposed

Loose Penetrations in Well Head

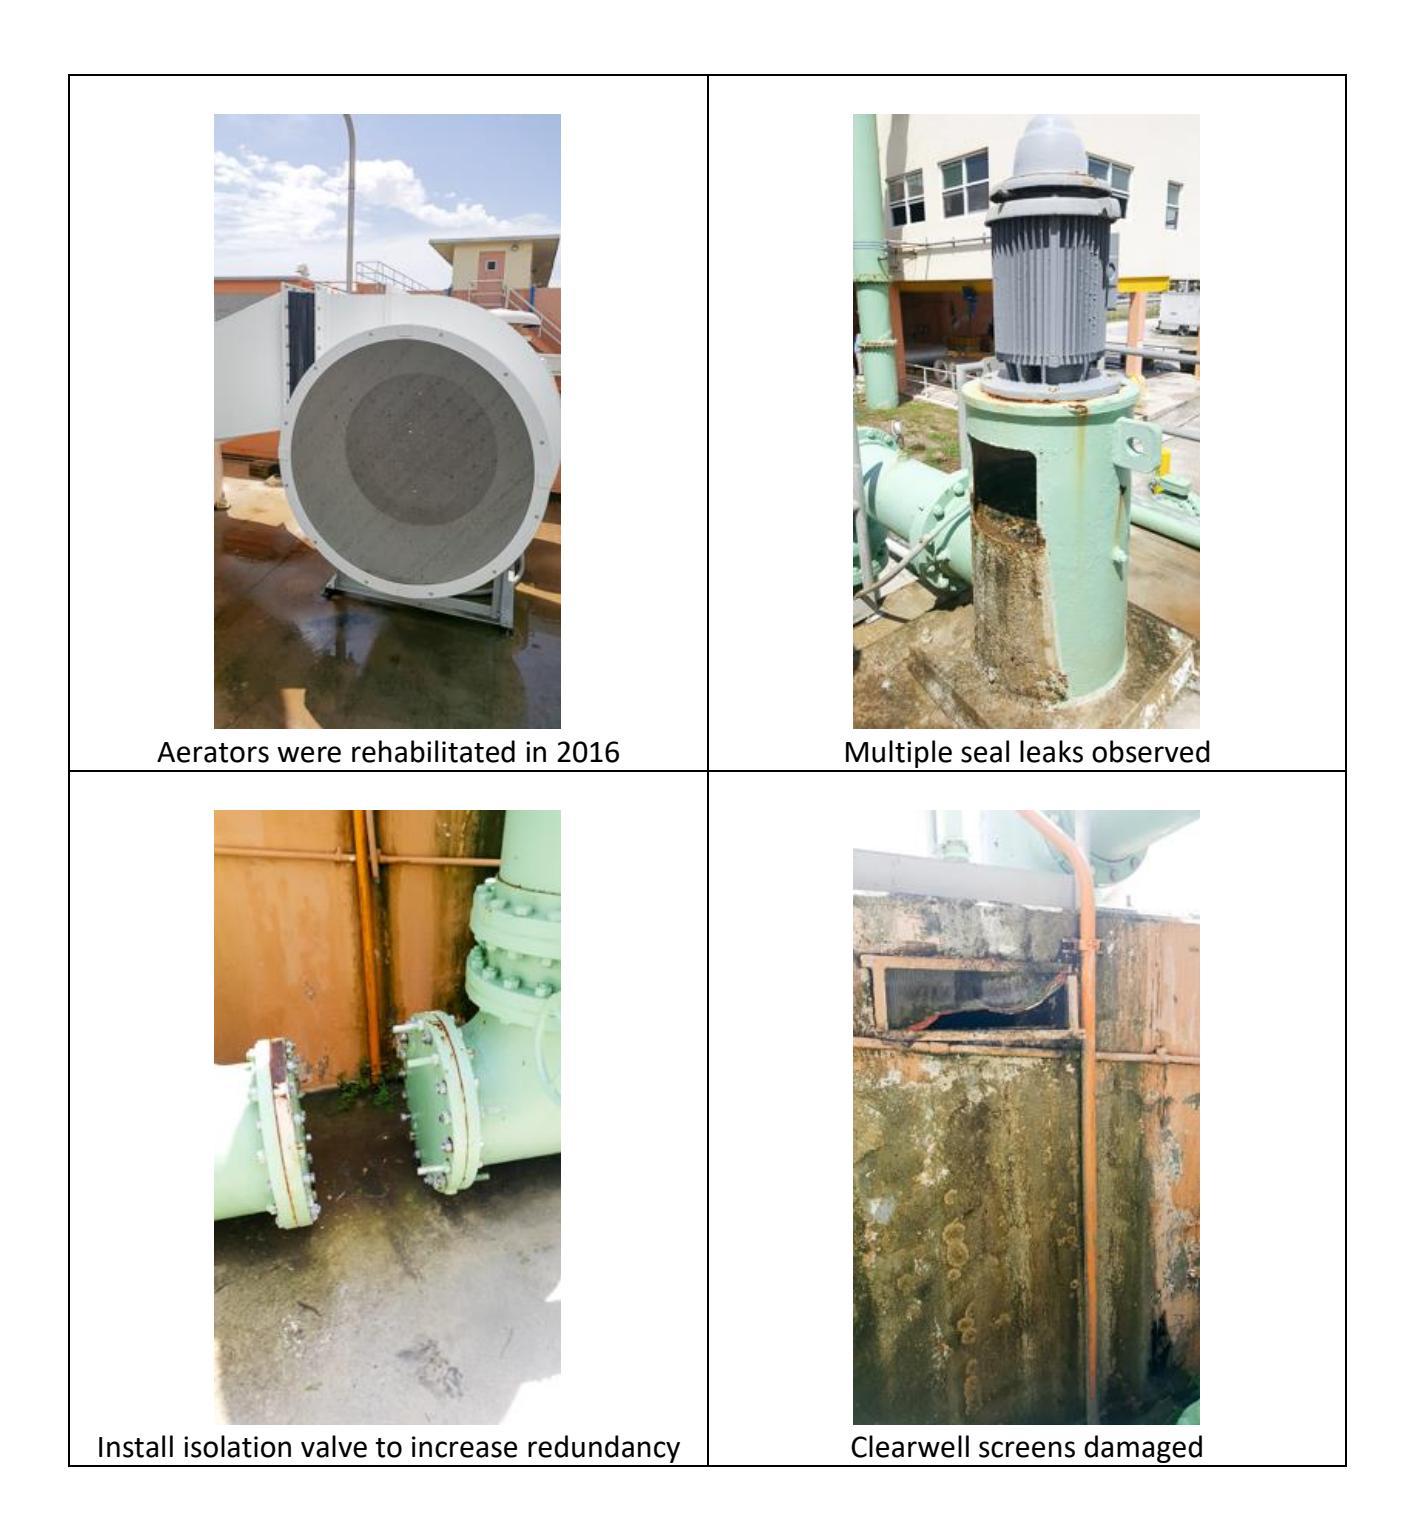
After aeration the water flows into a common clearwell located beneath the aerators. The water is then pumped into the lime softening process via six (6) transfer pumps. The header pipe on the pump discharges is capped in the center which dedicates three (3) pumps for the north lime softening unit (pumps 1B, 2B and 3B) and three (3) for the south and center lime softening units (pumps 1A, 2A and 3A). The center cap in the pump discharge header was achieved by removing a short, spool piece of pipe and replaced blind flanges. The clearwell has two (2) screened openings but both screens are damaged leaving the clearwell unprotected. There are multiple packing leaks that were observed on the transfer pumps resulting in heavy algae accumulation on the top and sides of the clearwell in addition to the sidewalk adjacent to the clearwell.

- Inspection window removed from aerator unit number 2
- Sulfuric Acid Feed Pump in poor condition
- Clearwell hatch not properly sealed or fully closed
- Broken and damaged conduit observed on top of clearwell
- Heavy accumulation of algae growth on clearwell top and sides
- Clearwell screens damaged
- Need proper pipe support for drain line
- Transfer pump discharge manifold segregated which limits redundancy

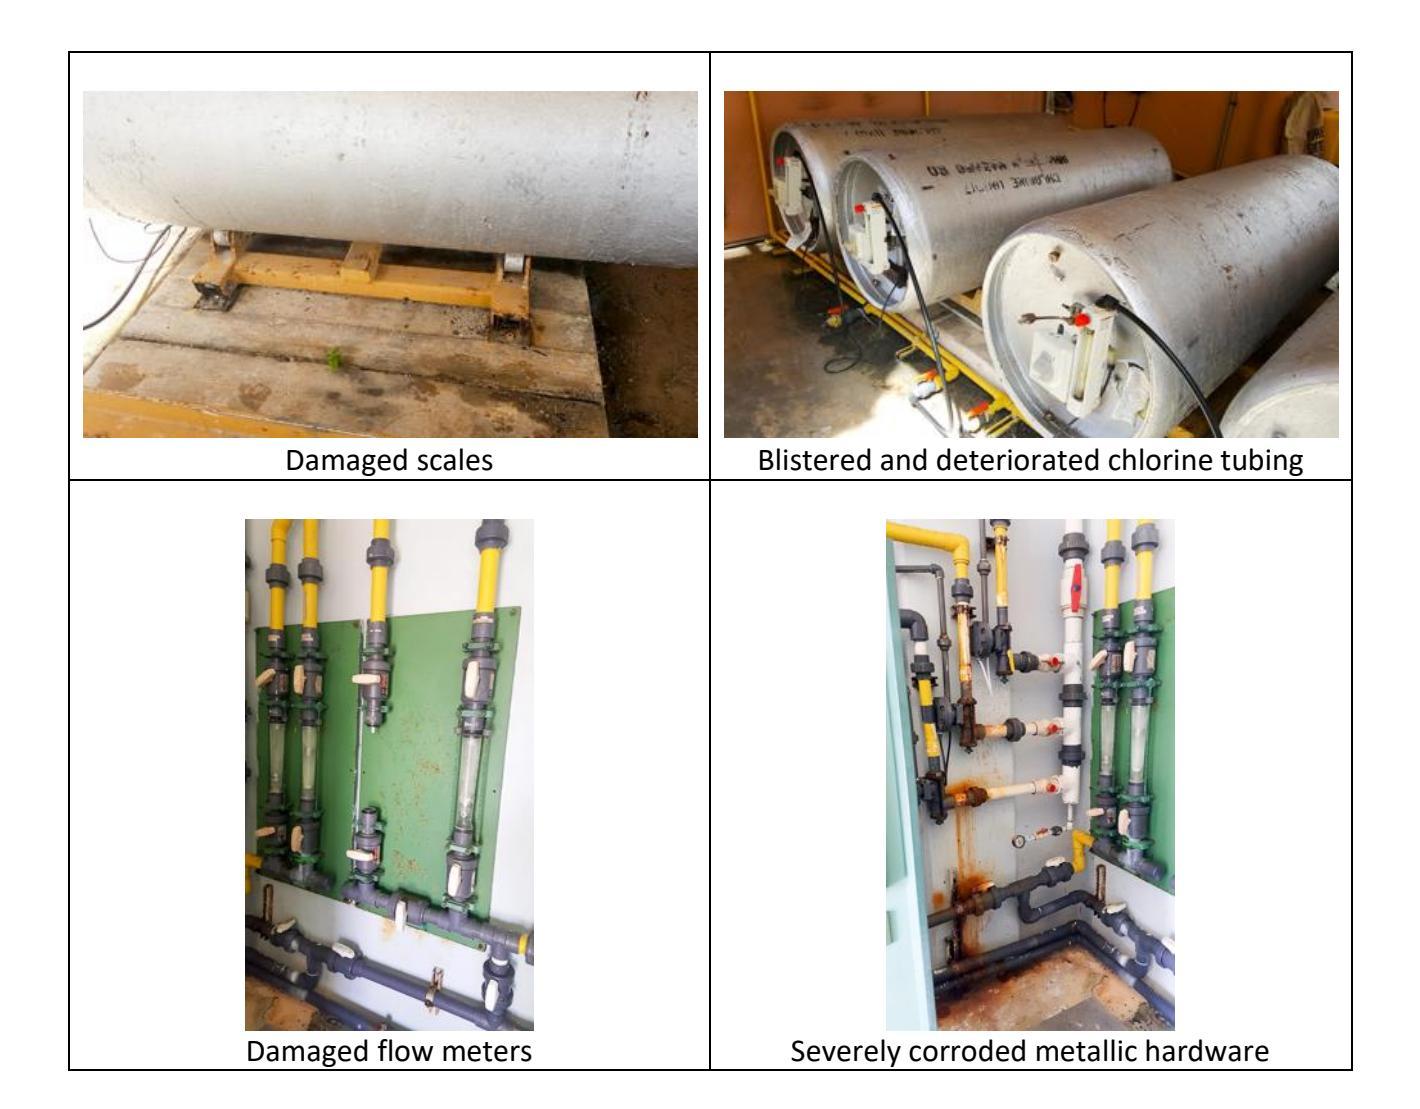
The chlorine cylinder units appear to be in fair condition but the flexible chlorine tubing is blistered and damaged. The overhead hoist was recently replaced and is in very good condition. A class B repair kit was found in the vicinity of the chlorine storage area and appeared to be a complete repair kit. There are multiple SCBA's (Self Contained Breathing Apparatuses) stored throughout the facility, but not all cabinets have an SCBA stored in them.

There is insufficient water pressure to provide reliable chlorine feed rates. The pressure is being depleted through water usage by other plant components, spray rings in the accelators, and insufficient hydraulic conveyance. Reliable pressure in the carrier water is necessary for consistent chlorine dosing. It was reported and observed that the limiting factor of chlorine dose is the lack of differential pressure required to create a vacuum. A dedicated water line or an inline booster should be installed to provide consistent and reliable chlorine feed.

The original flow paced chlorinators are all out of service and abandoned in place. Three (3) of the four (4) chlorinators were replaced with manually operated chlorinators. The chlorinators are dedicated as follows: one (1) to the north accelator, one (1) to the center and south accelators and one (1) for the clearwell. Once in solution the chlorine flows through flow meters mounted on the wall in the chlorine room, all of which are non-functional. Severe corrosion was observed on the metallic hardware in the chlorine room. The operations staff controls the chlorine feed rate to the four (4) application points in the south and center units via ball valves. This method does not allow for accurate chlorine dosing and creates the potential for uncontrolled intermittent breakpoint chlorination throughout the treatment process.

- Chlorine tubing blistered and damaged
- Inadequate water pressure resulting in intermittent reduction in chlorine feed
- Missing SCBA's in cabinets
- Severe corrosion in chlorine room
- Original chlorine injector at aerator transfer well removed by operations staff
- Insufficient feed control for south and center accelators
- New liquid chlorination system has been designed and is awaiting bid process.

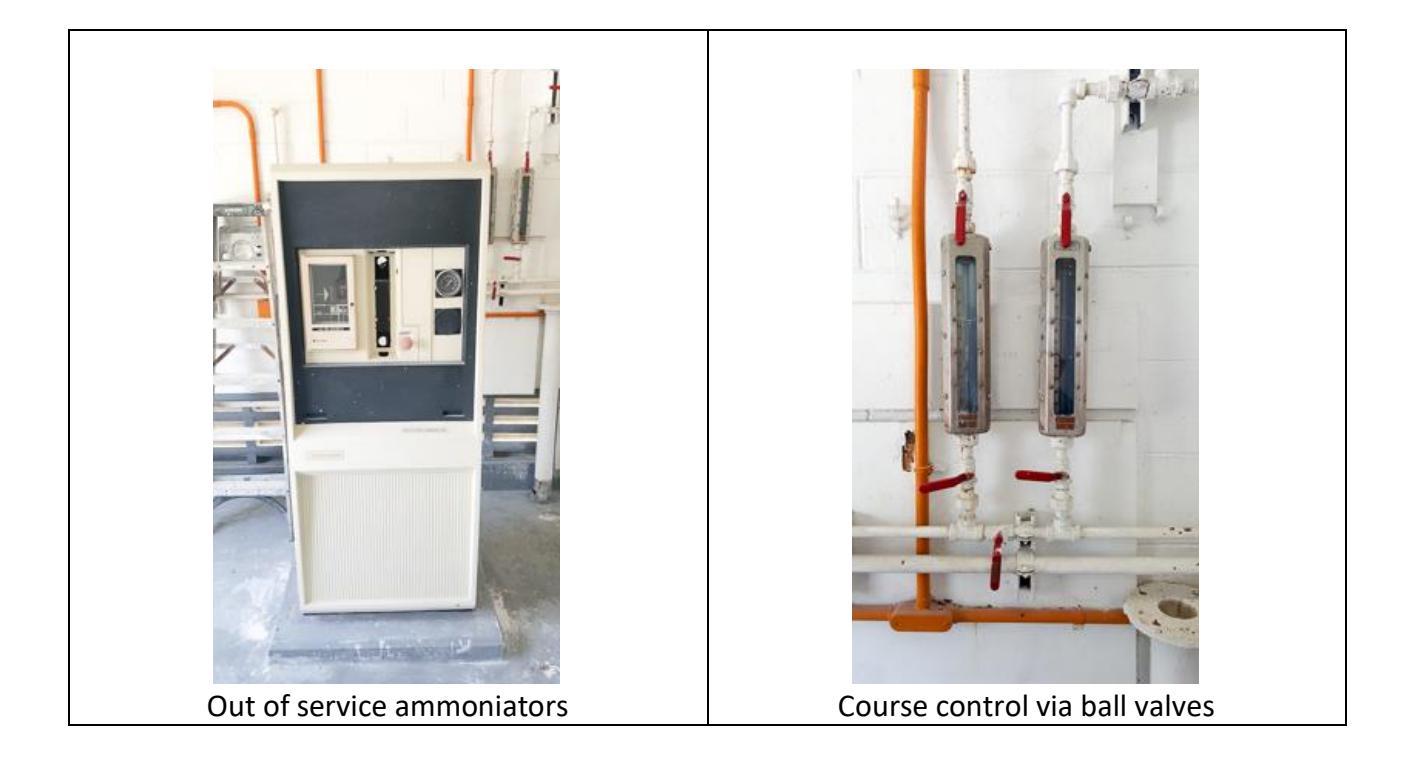
The facility feeds anhydrous ammonia that is combined with chlorine to form the chemical compound monochloramine. Monochloramines are used to reduce the formation of disinfection by-products (TTHM's and HAA5's) that are readily formed in the presence of free chlorine. The ammonia system consists of an ammonia storage tank, two (2) ammoniators and associated appurtenances. The storage tank was recently replaced by the chemical supplier and is in very good condition. The two (2) ammoniators are both out of service. Ammonia feed rates are controlled manually through a rotameter using ball vales to regulate the flow rates. Ammonia is delivered in a gaseous state to the point of injection. There is a minor ammonia leak in the ammonia room and the ammonia injection point to the north accelator is clogged. Ammonia can only be injected at two locations throughout the treatment process, into the north and south riser pipes that feed the lime softening units. An additional ammonia injection point should be installed in the clearwell to provide a redundant ammonia injection and the ability to increase the chlorine residual in the finished water.

- Ammonia leak in ammonia room
- Ammonia leak at unit 3 injector
- Original ammonia injector at aerator transfer well removed by operations staff
- Provide post ammonia injection at finished water clearwell location

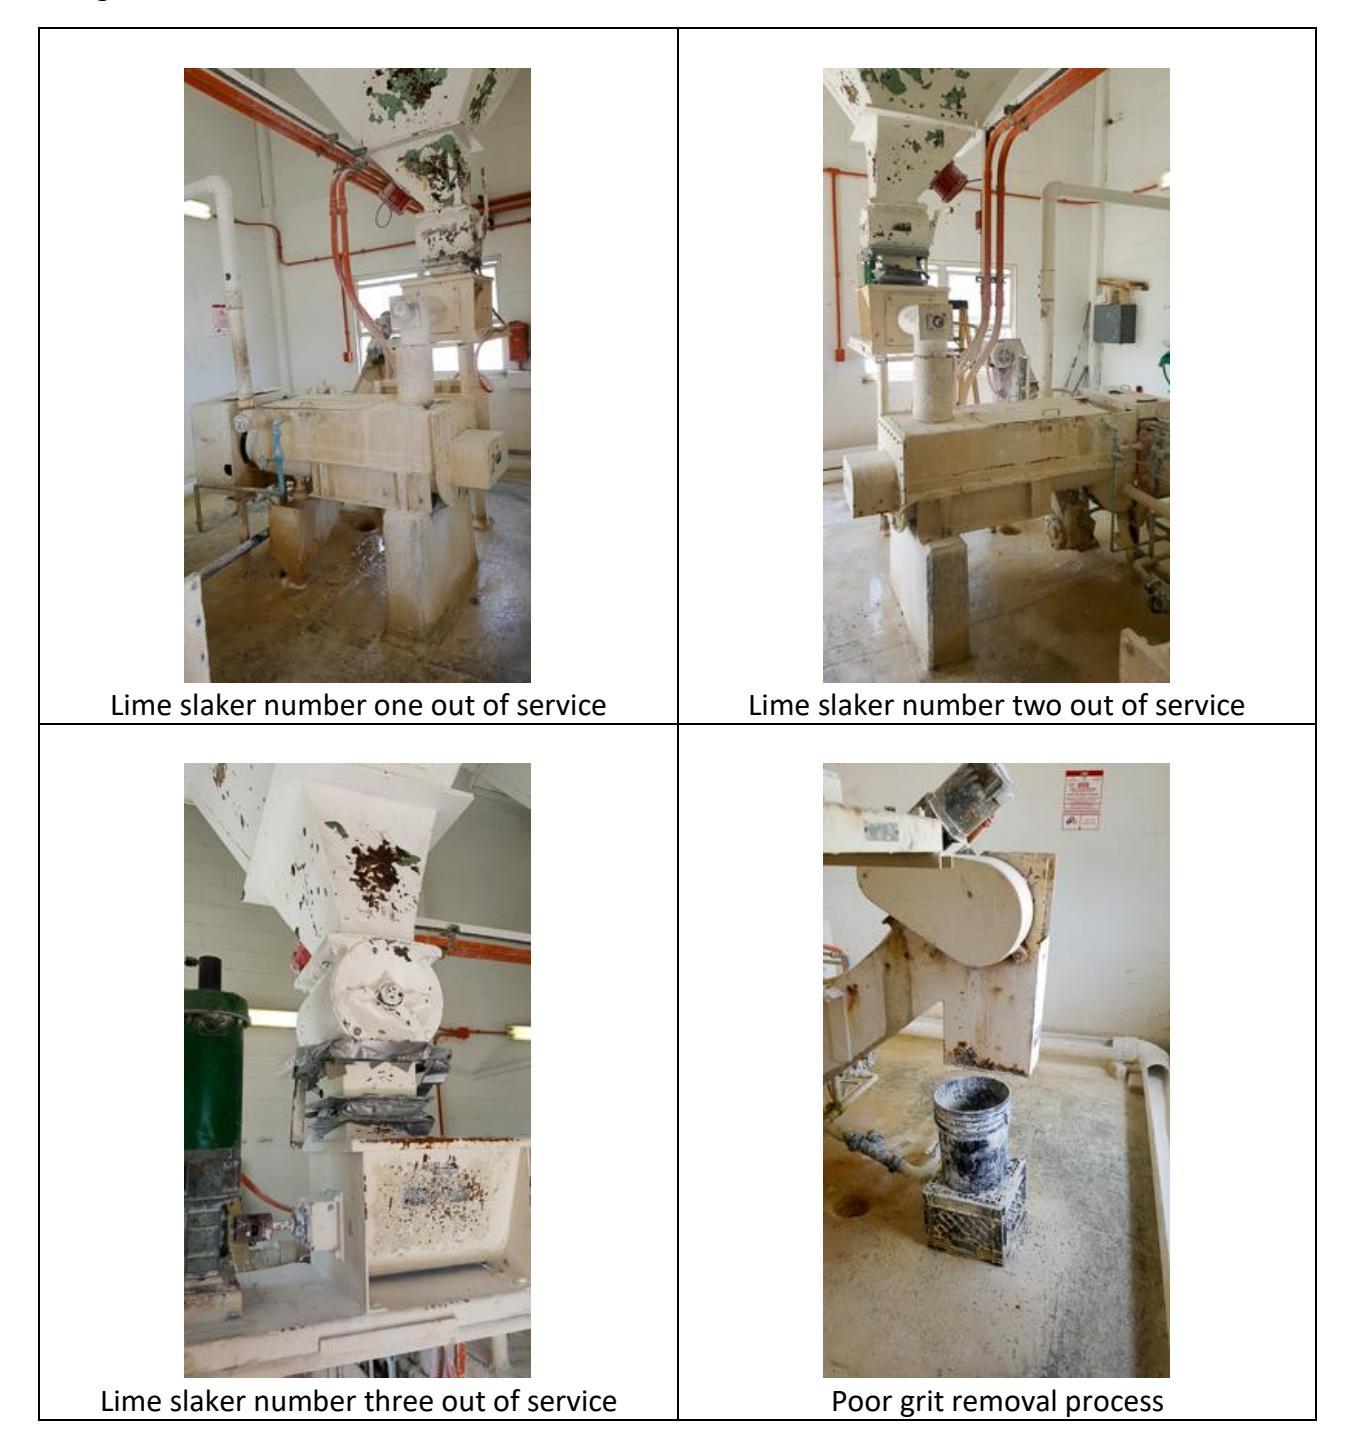
Slaker number one (1) is also out of service leaving Slaker number two (2) as the only means of feeding lime into the system. Grit is separated during the slaking process from the lime and dropped into buckets. During the plant assessment USWSC found evidence of the grit buckets being emptied through third floor windows onto the ground below.

The lime slurry splitter box used to control the lime slurry feed to the south and center softeners does not provide accurate controlled feed rates. Only course adjustments can be made while using a single slaker.

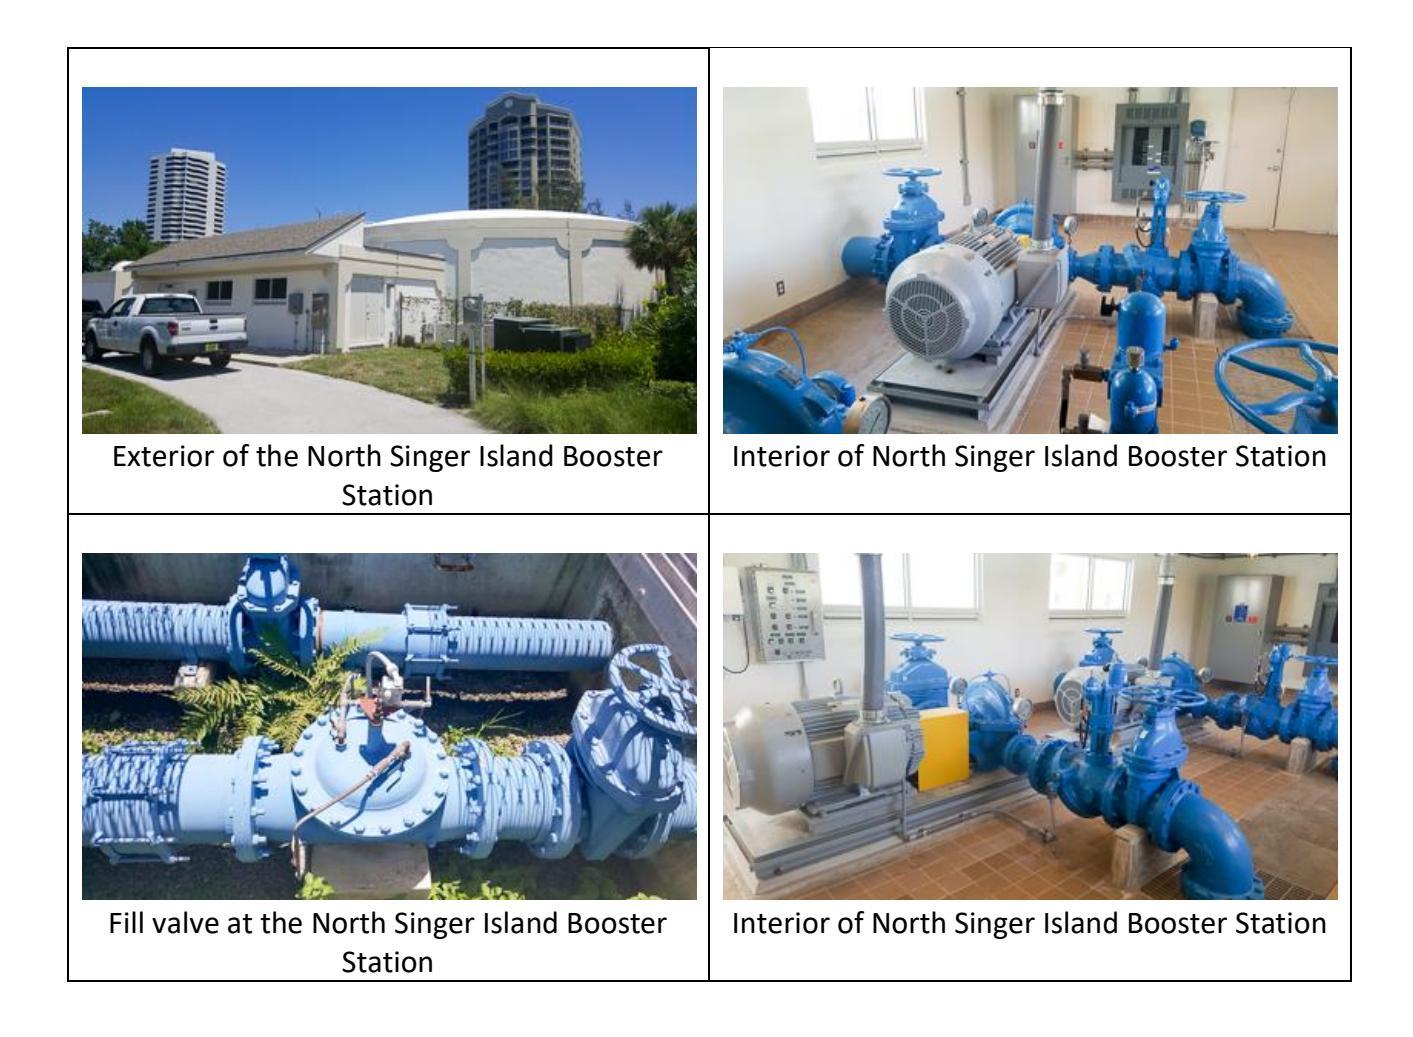
The North Singer Island booster station consists of a one-million-gallon ground storage tank, hydropneumatic tank and two variable frequency drive high service motors. The station does not have the capability to feed chlorine or ammonia at this time. The station is in generally very good condition having been rehabilitated in 2009. One high service pump was inoperable at the time of USWSC inspection
