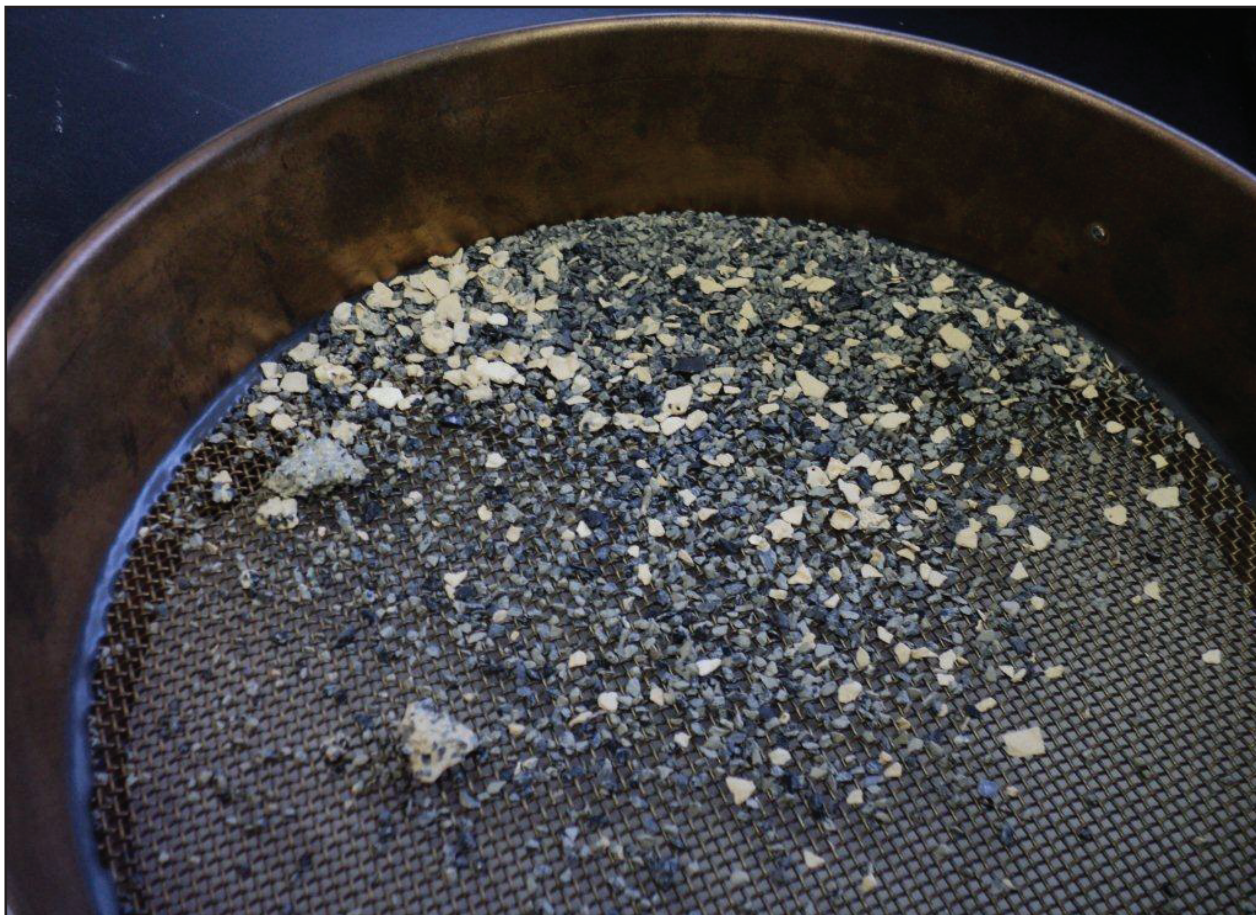
Figure 8-12
Mudballs and Calcium Chips
Typical of Filters 4 and 8

Contains mudballs
and calcium chips

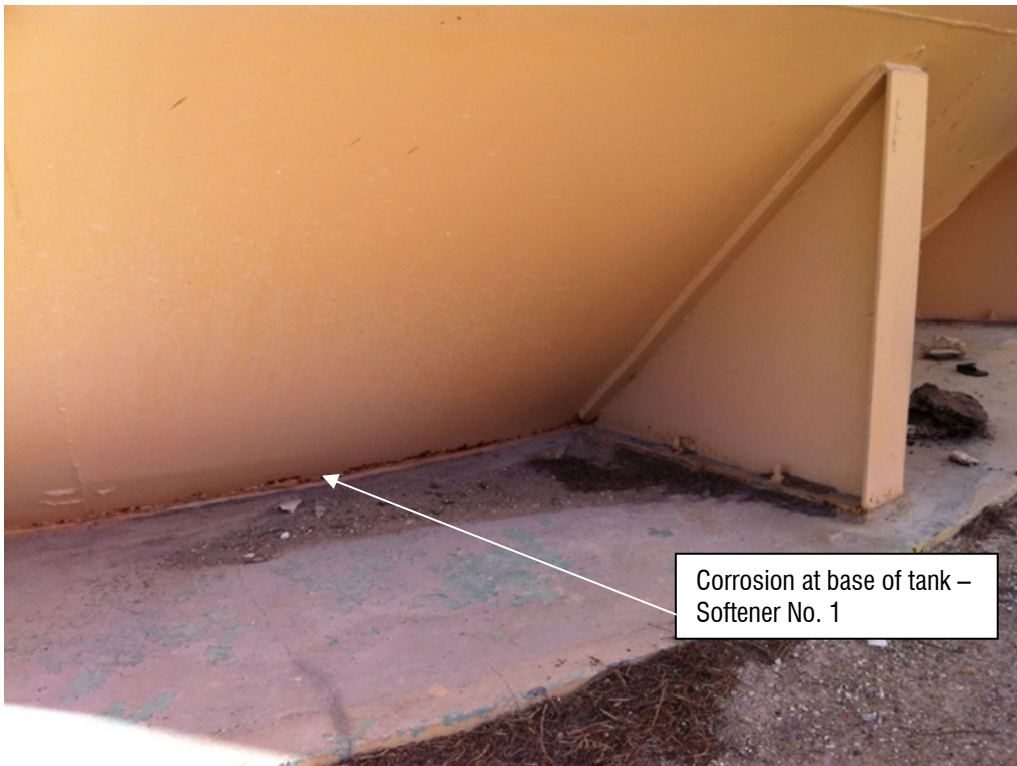
Picture A.9-6 Softener No. 1 Base of Tank

Corrosion at base of tank –
Softener No. 1

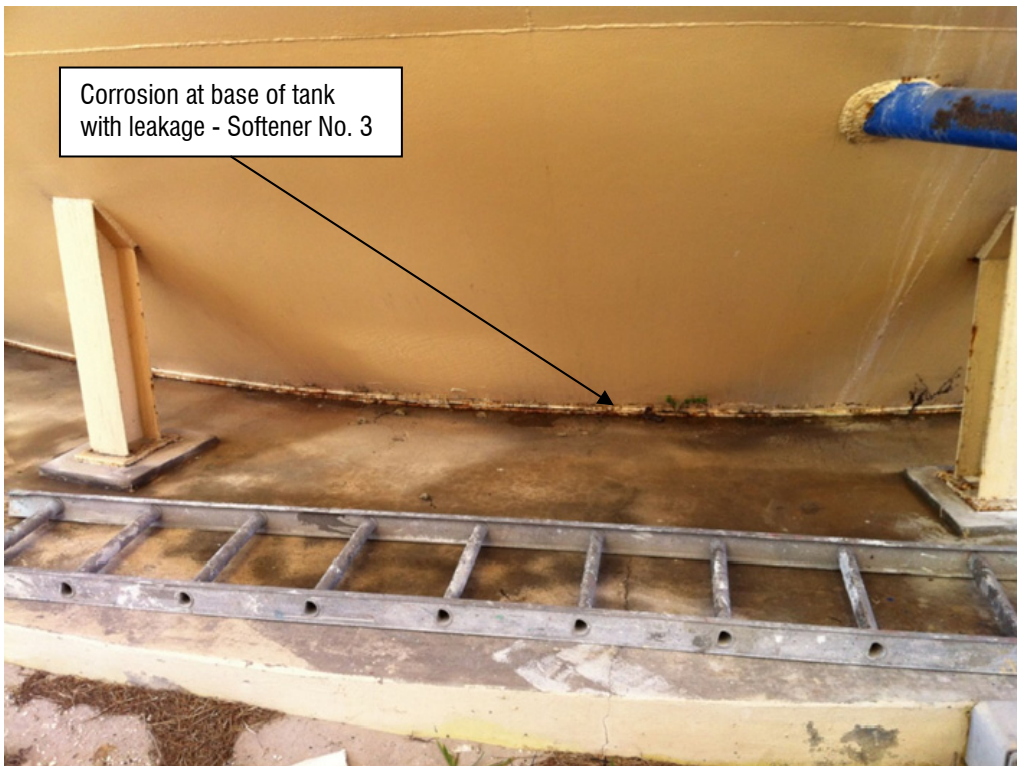
Picture A.9.7 Softener No. 3 Base of Tank

Corrosion at base of tank
with leakage - Softener No. 3

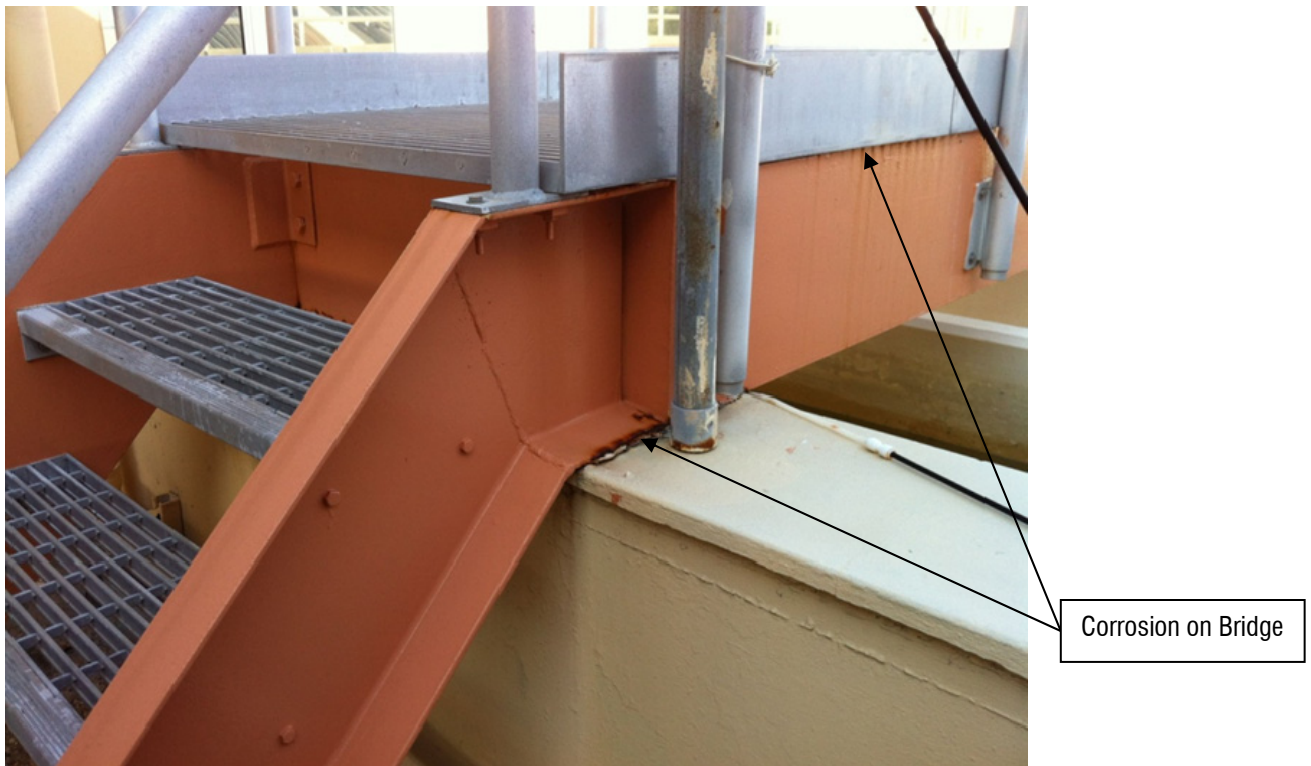
Picture A.11.3 Bridge Corrosion on South Filter Bank

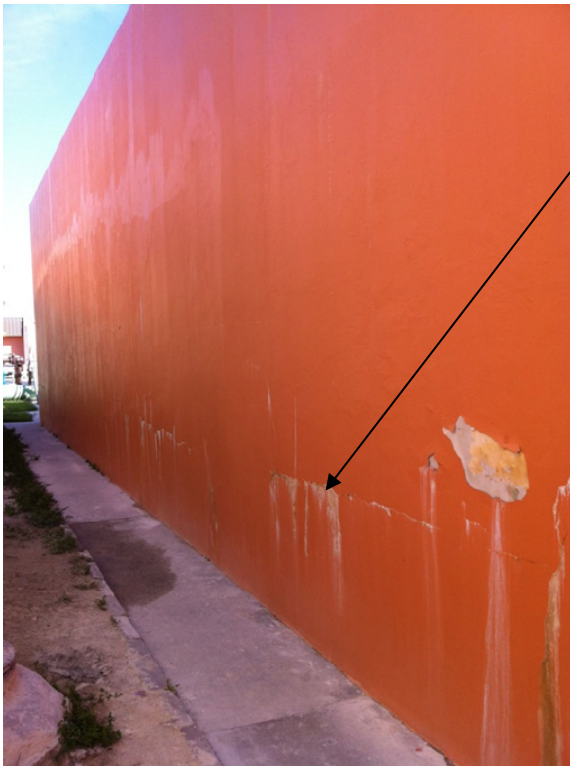
Picture A.11.8 Exterior West wall of Filters No. 9, 11, 13, and 15

Cracks along west wall of Filters No. 9,11,13, and 15 with leakage

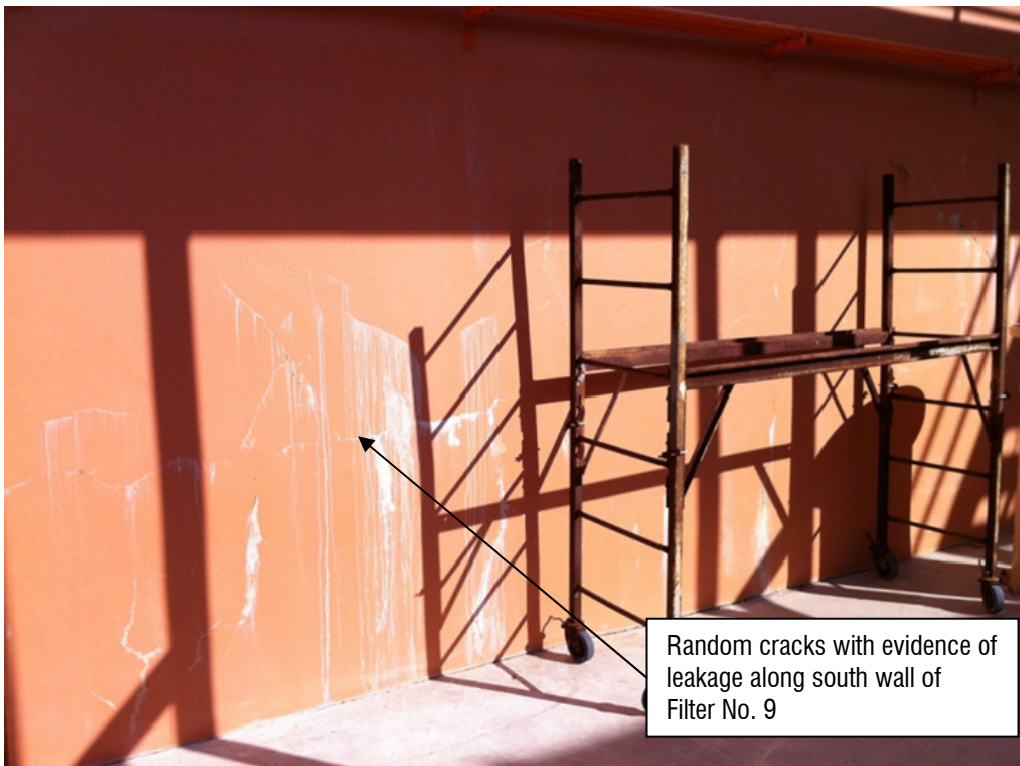
Picture A.11.9 Exterior South wall of Filter No. 9

Random cracks with evidence of leakage along south wall of Filter No. 9

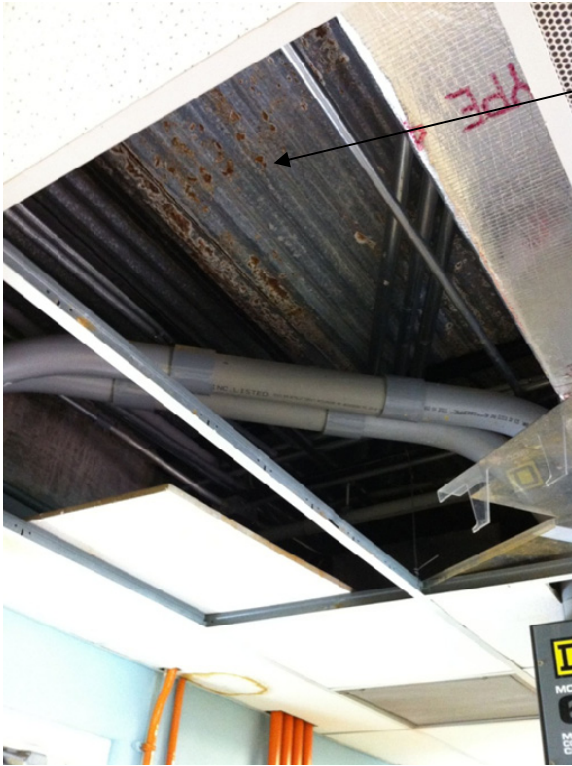
Corrosion of roof metal deck above Main MCC Room
