City of Riviera Beach

Assessment, Analysis and

Corrective Action Related to

Consent Order for Utility District

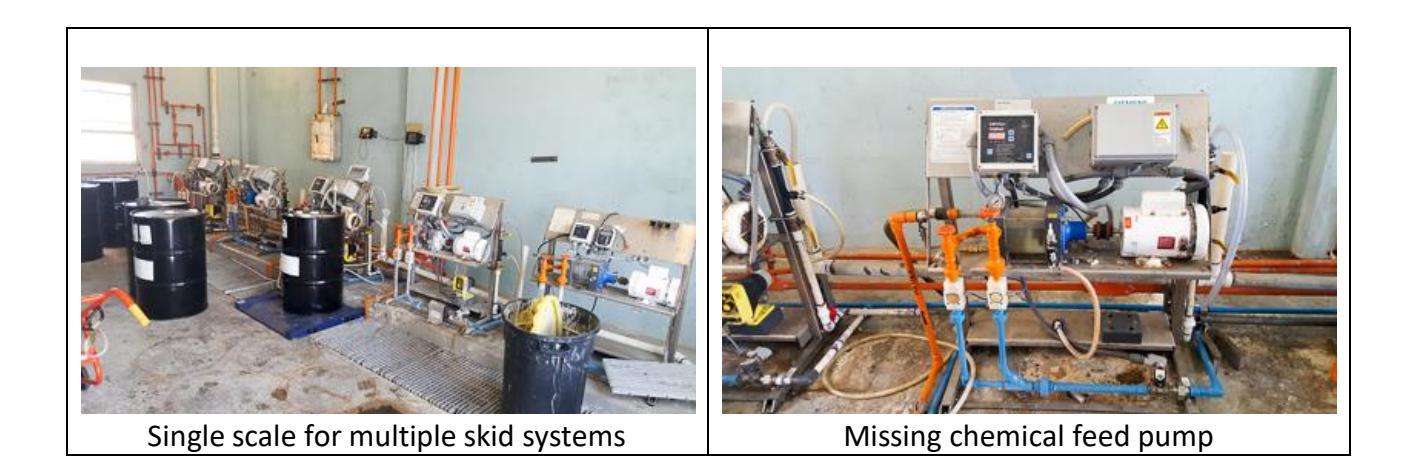
Table 11-1 Polymer Critical Equipment List

Polymer is fed at the water treatment facility as a necessary coagulant in the lime softening treatment process. Polymer is essential to remove the suspended particles that will not settle out naturally. There are five (5) polymer feed skids installed in the polymer feed room. They consist of a metering pump in combination with a carrier water pump used to deliver polymer to the point of application. There are two (2) inoperable scales mounted to the wall in the polymer room and one (1) functional scale. The current operation requires two (2) polymer skids to feed polymer concurrently. With only one functional scale in the room it is not possible to monitor polymer usage via weight as originally designed. Also, there are only two (2) operational polymer feed skids, the other three (3) are out of service and/or missing critical parts.

ltem	Recommendation	Consent Order Rating	Estimated Cost
Polymer Feed System 1	Replace chemical metering pump	0	\$ 20,000
	Perform routine preventive		
Polymer Feed System 2	maintenance	2	\$ 1,000
Polymer Feed System 3	Replace chemical metering pump	0	\$ 20,000
	Perform routine preventive		
Polymer Feed System 4	maintenance	2	\$ 1,000
Polymer Feed System 5	Duplicate spare. Repair and replacement not needed at this time	N/A

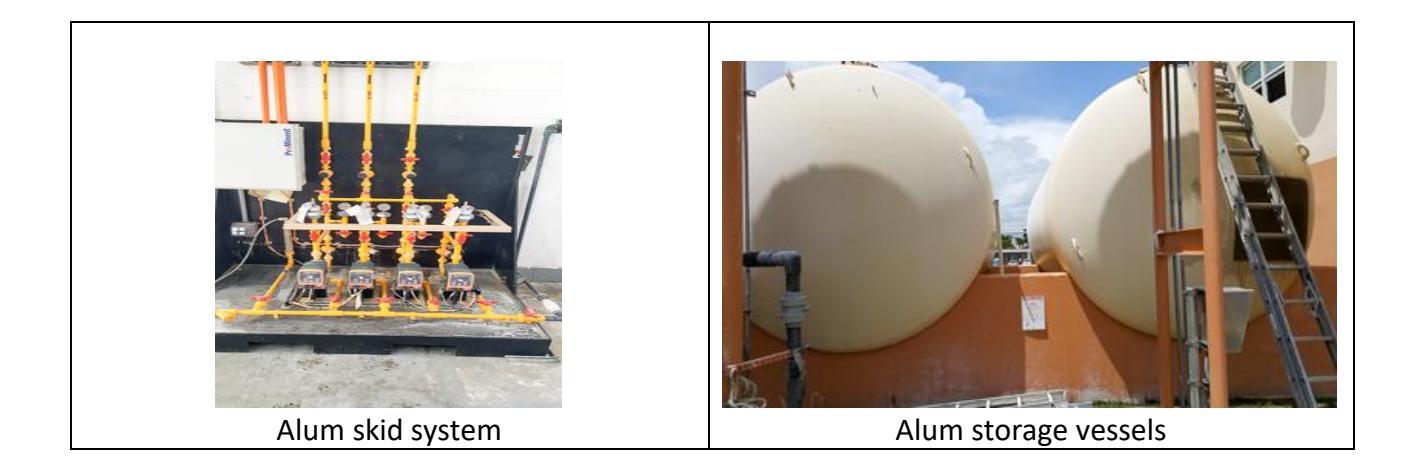
Table 12-1 Alum Critical Equipment List

Alum (aluminum sulfate) is fed at the primary mixing zone of the accelators. Alum is fed as a coagulant to aid in flocculation and settleability. Alum is pumped into the softening units by a chemical pump skid consisting of four (4) pumps. Further investigation is needed to ensure the alum is being dosed at the optimal dose. There are two steel storage tanks for alum storage; the north storage tank has a large repair on the end cap. There is no means to monitor the level of alum in the storage tank. Level measurement is accomplished by an operator climbing to the top of the tank to perform a visual measurement.

Item	Recommendation	Consent Order Rating	Estimated Cost
Alum Skid Feed System (4 Pumps)	No repairs needed	3	
Alum Storage Vessel - North	Replace Alum storage tanks	1	\$ 30,000
Alum Storage Vessel - South	Replace Alum storage tanks	1	\$ 30,000

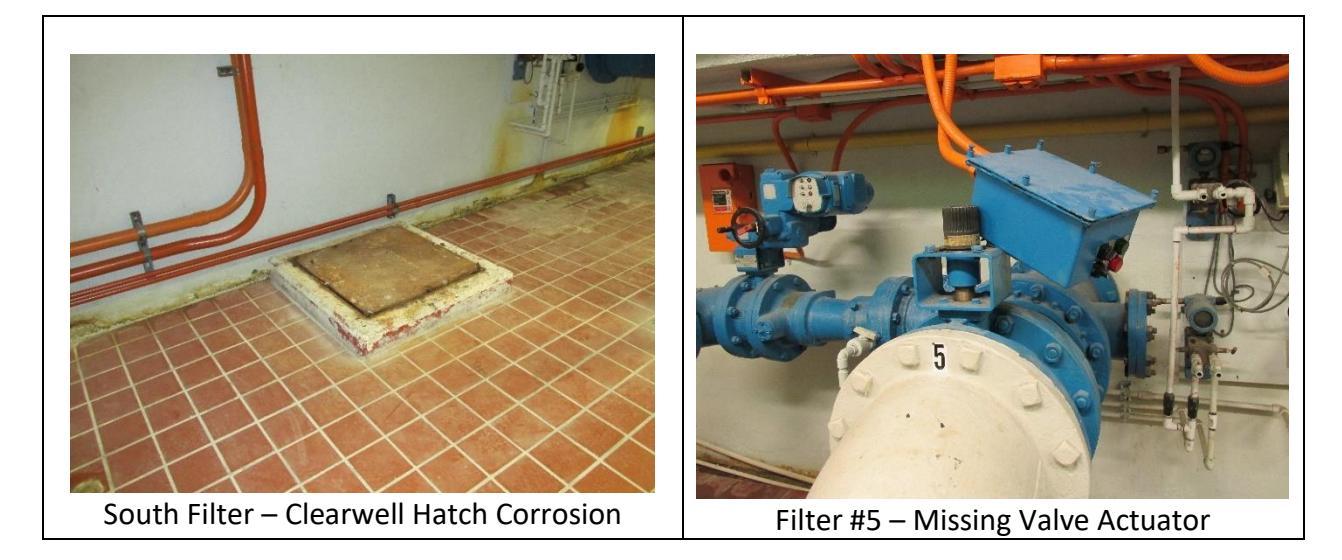
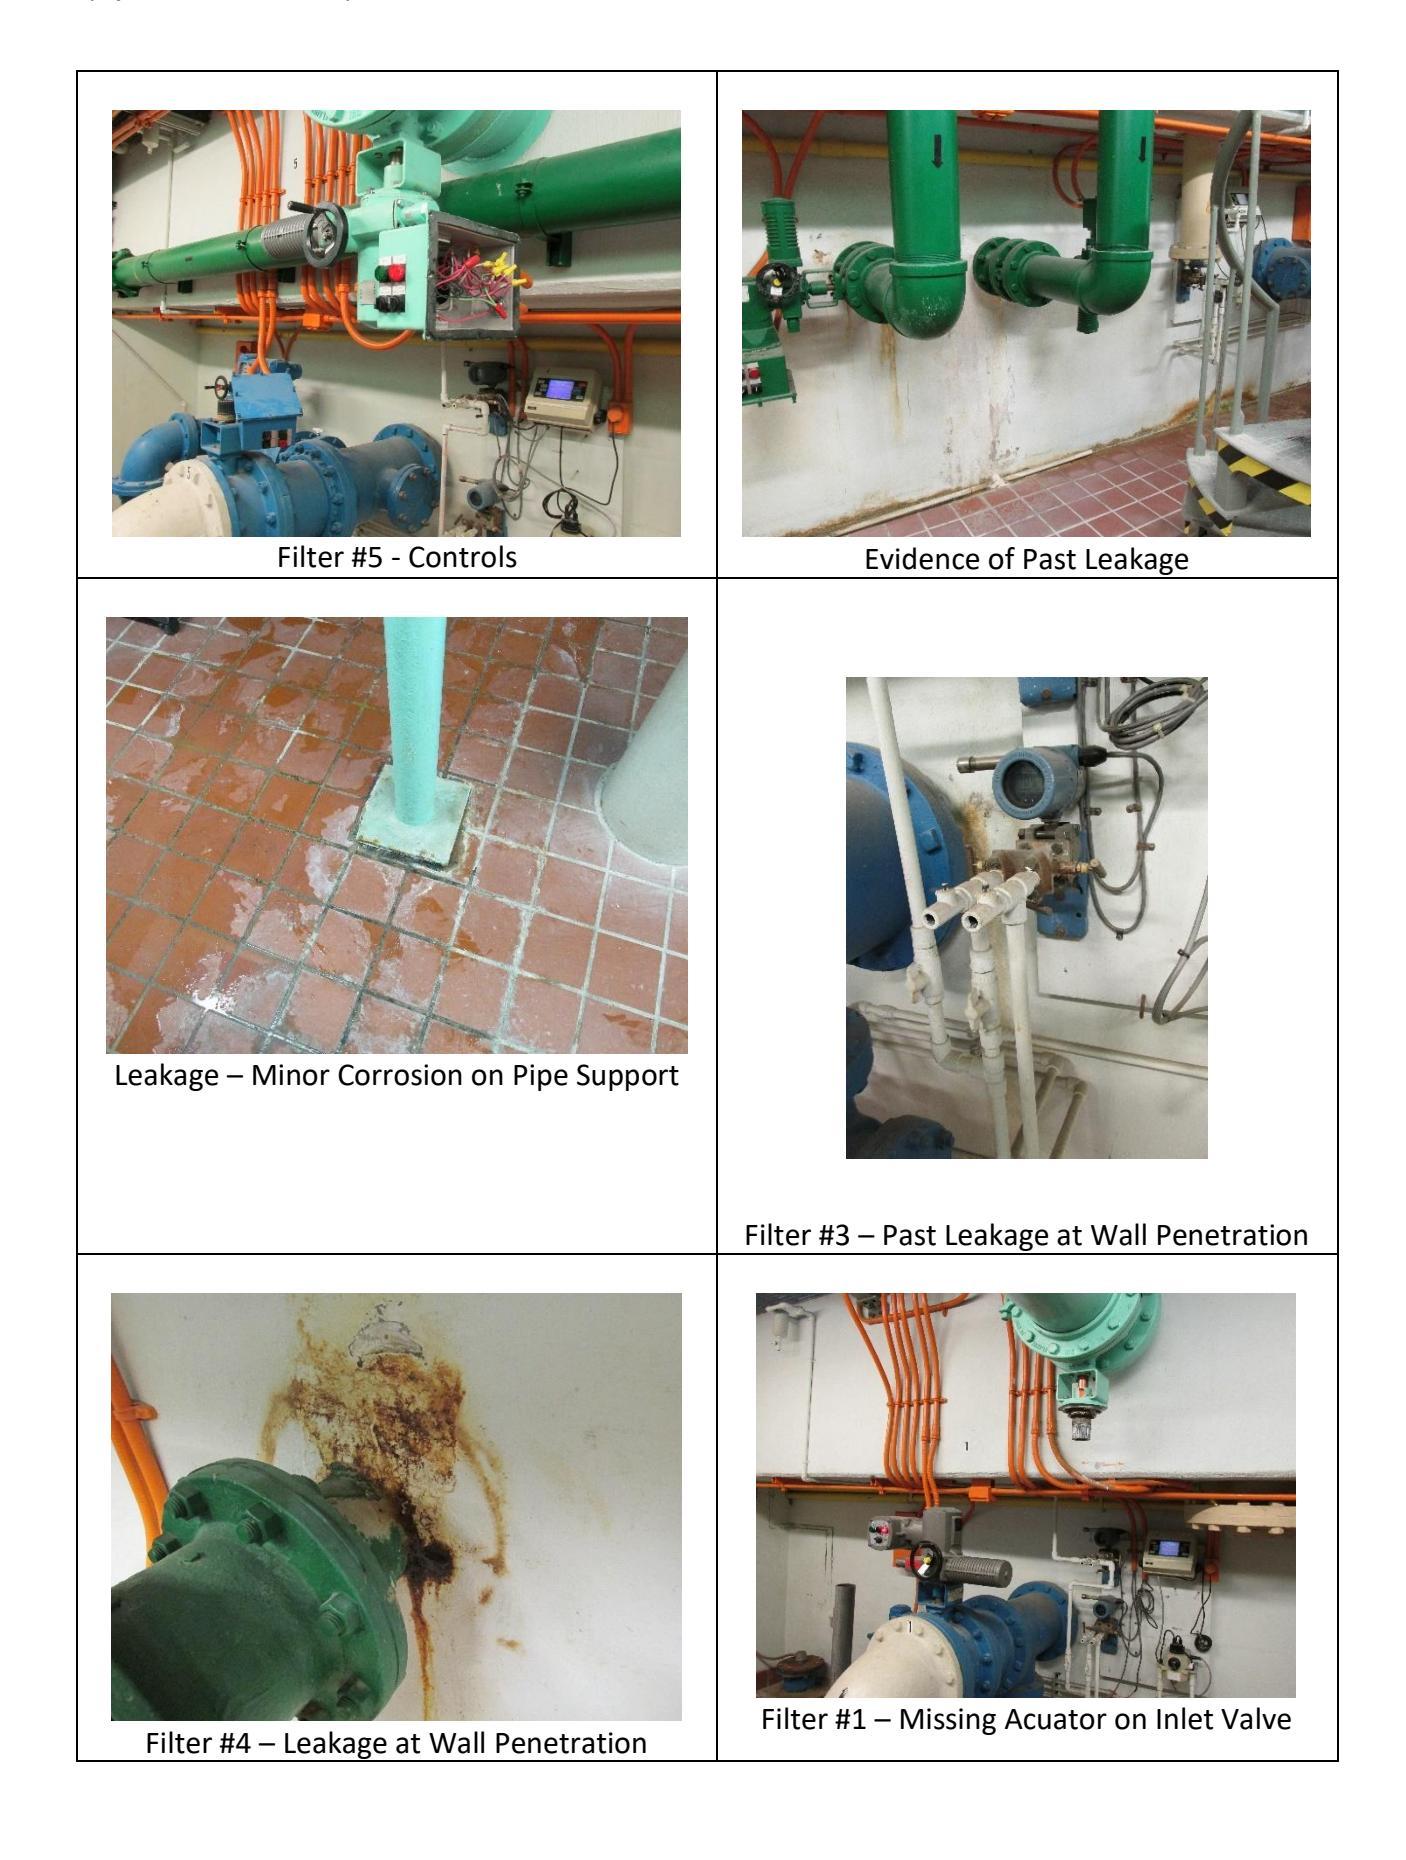
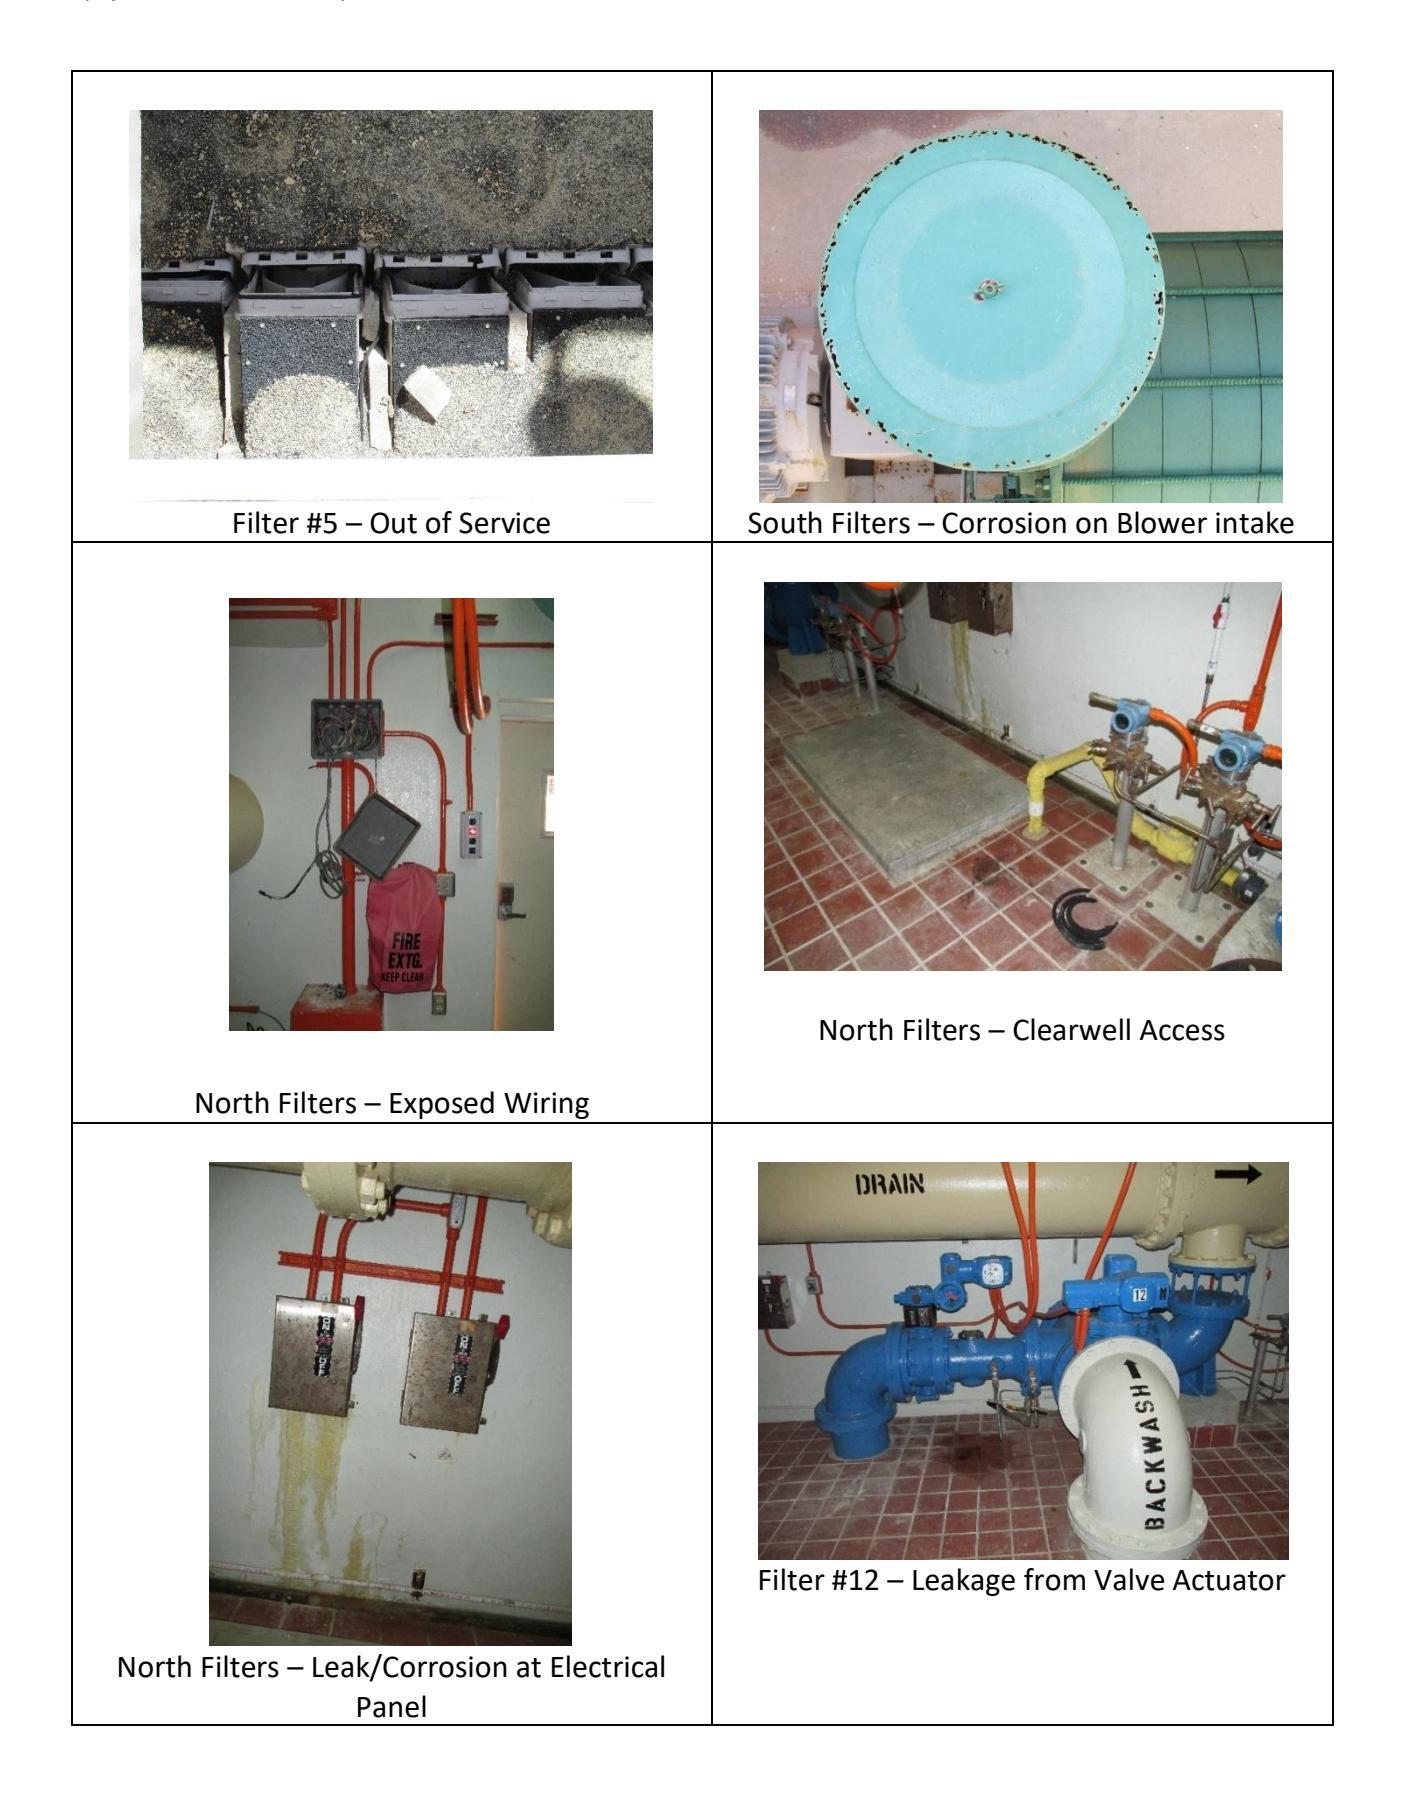
Table 14-2 Filters Critical Equipment List

The measurements above indicate there are various amounts of filter media in each filter. USWSC believes that some of the filters have experienced substantial filter bed loss through the backwashing system. It is also likely some filter media expansion has taken place due to calcium carbonate buildup on the media. Further investigation including media testing and core sampling should be conducted to determine an appropriate media schedule. Original plans from 1980 indicate filter media should be 51 inches from the top of the wash trough launders to the top of the media.

Consent Order	Estimated
Item	Recommendation	Rating	Cost
Filter Number 1	Replace missing actuator on inlet valve	1	\$ 8,000
Filter Number 2	No repairs needed	2	
Filter Number 3	No repairs needed	2	
Filter Number 4	No repairs needed	2	
Filter Number 5	Repair underdrain, replace valve actuators and media to restore to service	0	\$ 50 000 - \$ 75 000
Filter Number 6	No repairs needed	2	<i>\$ 30,000 \$ 73,000</i>
Filter Number 7	No repairs needed	2	
Filter Number 8	No repairs needed	2	
Filter Number 9	No repairs needed	2	
Filter Number 10	No repairs needed	2	
Filter Number 11	No repairs needed	2	
Filter Number 12	No repairs needed	2	
Filter Number 13	No repairs needed	2	
Filter Number 14	No repairs needed	2	
Filter Number 15	No repairs needed	2	
Filter Number 16	No repairs needed	2

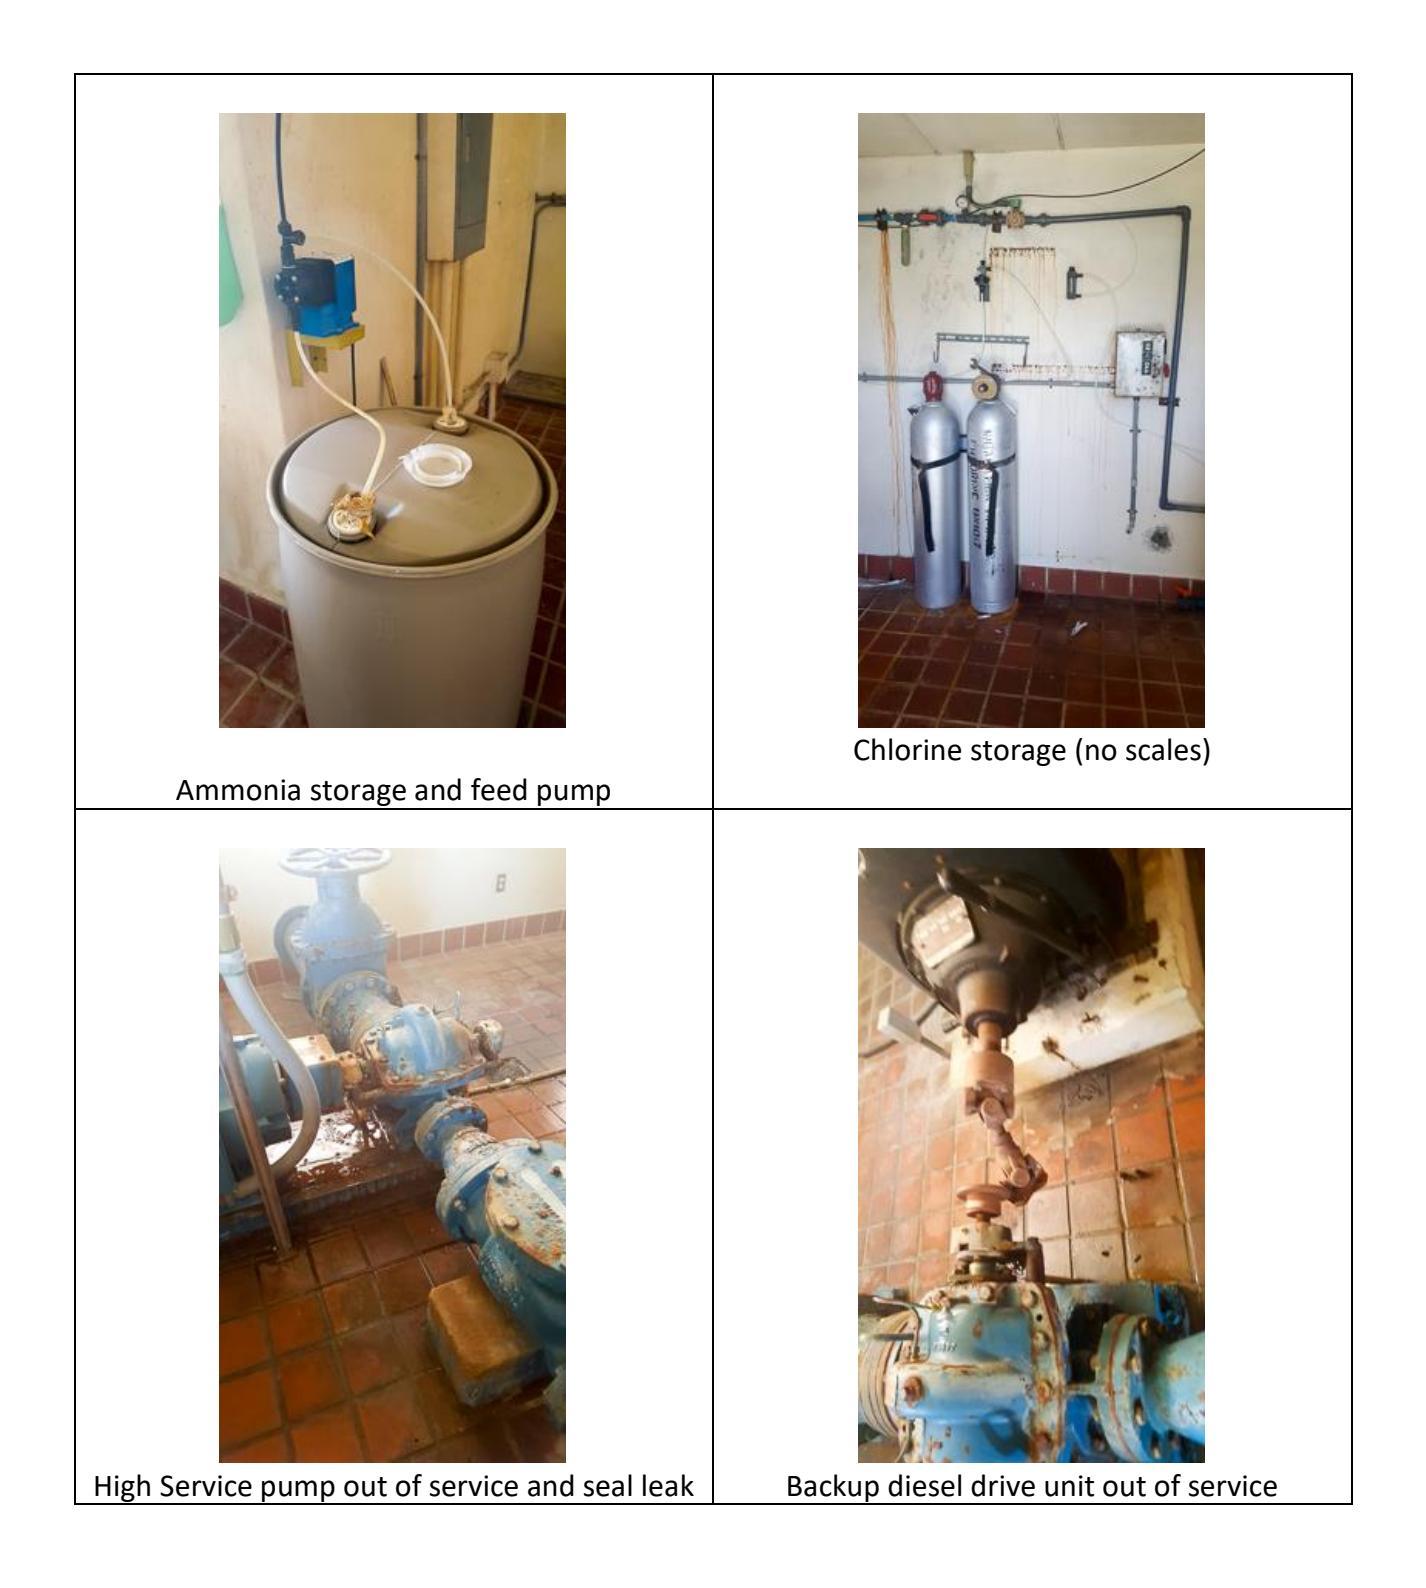
Table 18-2 Avenue C Booster Station Critical Equipment List

Consent	
		Order	Estimated
Item	Recommendation	Rating	Cost
High Service Pump Number 1	Rehabilitate pump assembly	1	\$ 5,000 - \$ 15,000
High Service Pump Number 2	Rehabilitate pump assembly	0	\$ 5,000 - \$ 15,000
1 million gallon ground	Replace screens with tighter		
storage tank	mesh	1	\$ 500
Chlorine Cylinder Unit Number			
1	No repairs needed	2	
Chlorine Cylinder Unit Number	Replace removed chlorine		
2	cylinder unit	0	\$ 5,000
Chlorine Scales	Replace removed chlorine scales	0	\$ 4,000
Chlorine Automatic			
Switchover	Install new Cl2 switchover	0	\$ 2,500
	Tank inspection reports have		
Hydro-pneumatic tank	been requested	2	
Auxiliary Pumping system	Install auxiliary generator	0	\$ 75,000 - \$ 150,000
Chlorine Leak Detector	Replace leak detector	1	\$ 4,500

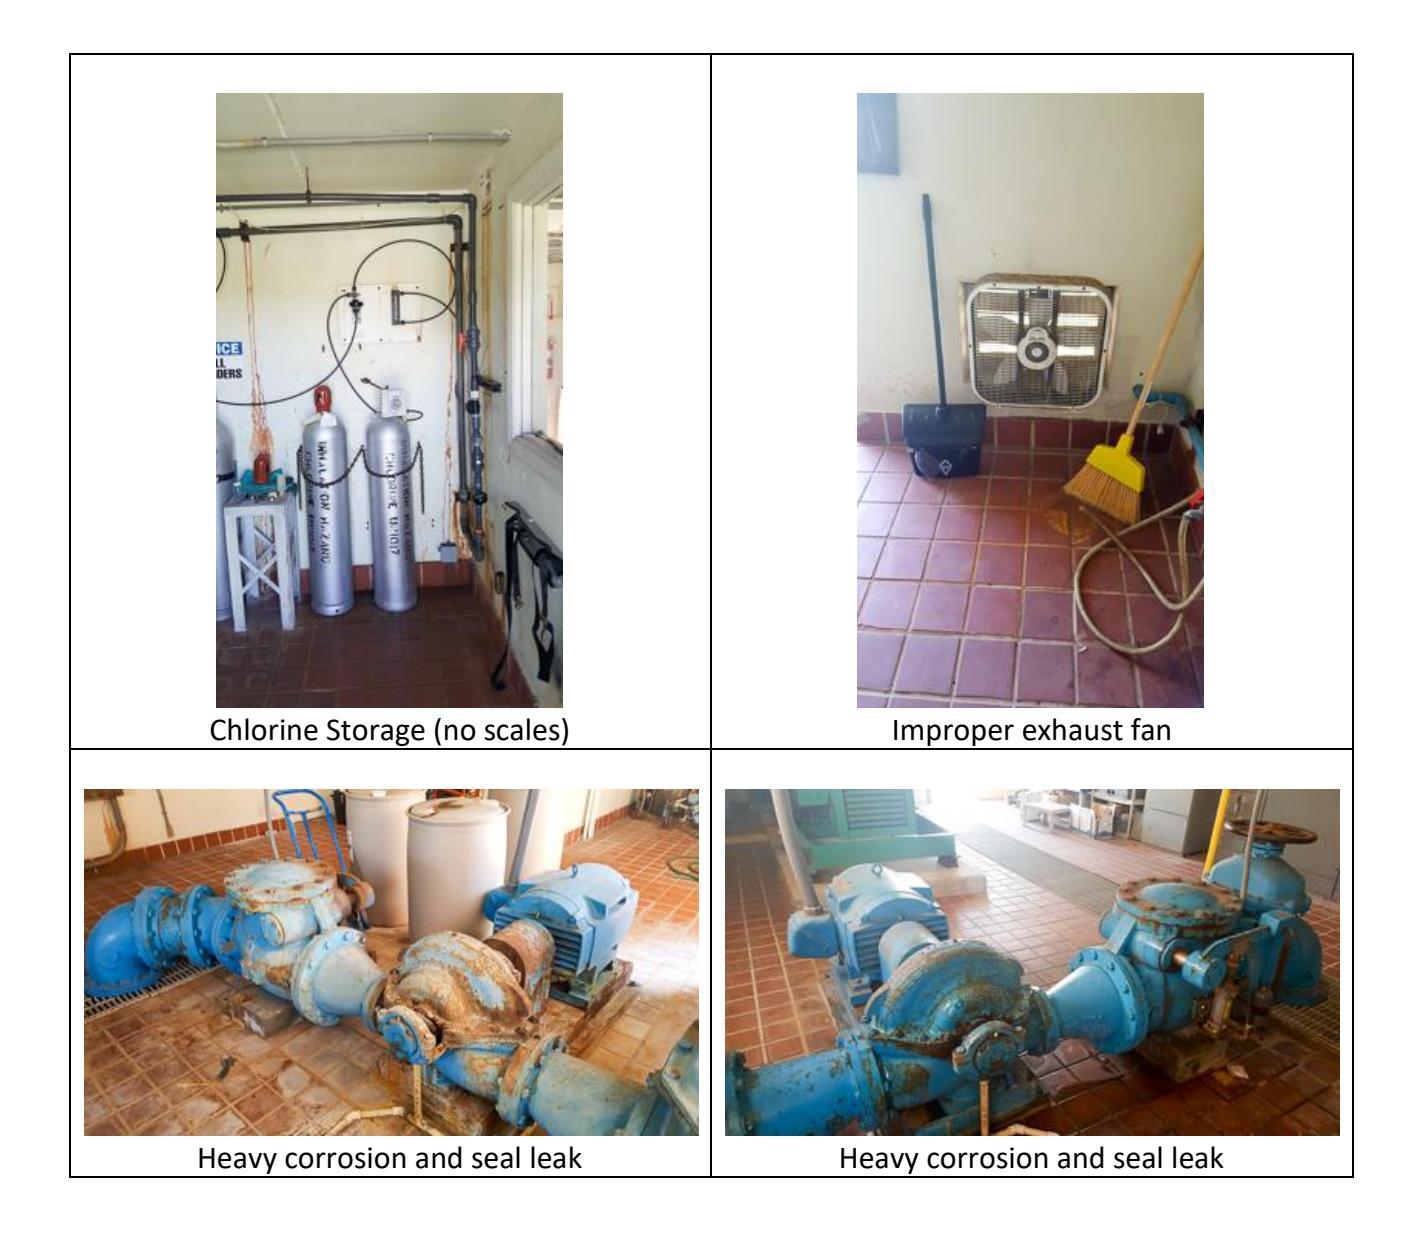
Table 18-3 Avenue U Booster Station Critical Equipment List

Consent	
		Order	Estimated
Item	Recommendation	Rating	Cost
			\$5,000 -
High Service Pump Number 1	Rehabilitate pump assembly	1	\$15,000
			\$5,000 -
High Service Pump Number 2	Rehabilitate pump assembly	0	\$15,000
1 million gallon ground storage			
tank	Replace screens with tighter mesh	0	\$ 500
Chlorine Cylinder Unit Number 1		2	
	Replace removed chlorine cylinder		
Chlorine Cylinder Unit Number 2	unit	0	\$ 5 <i>,</i> 000
Chlorine Scales	Replace removed chlorine scales	0	\$ 4,000
Chlorine Automatic Switchover	Install automatic switchover	0	\$ 2,500
Chlorine Leak Detector	Replace leak detector	0	\$ 4,500
	Automatic transfer switch out of		\$5,000 -
Auxiliary power	service. Replace	0	\$25,000
	Tank inspection reports have been		
Hydro-pneumatic tank	requested	2
